# OVERHEAD POWERLINE INCIDENT

**Incident:** Crane boom contact with 110KV Overhead Power line

**Date of Incident:** 08/06/2015

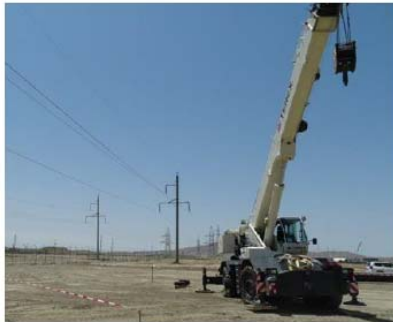
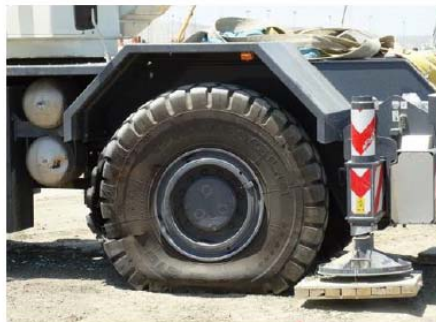
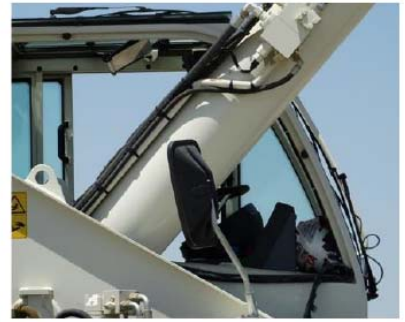
The surge of power resulted in three of the crane tyres rupturing and one of the cab side windows shattering. The ruptured tyres rendered the crane immobile. No one was injured during the incident

Ruptured Tyres and Shattered Cab Window
