# QSHE ALERT 2018-04

## “Water and air” under pressure are a bad combination

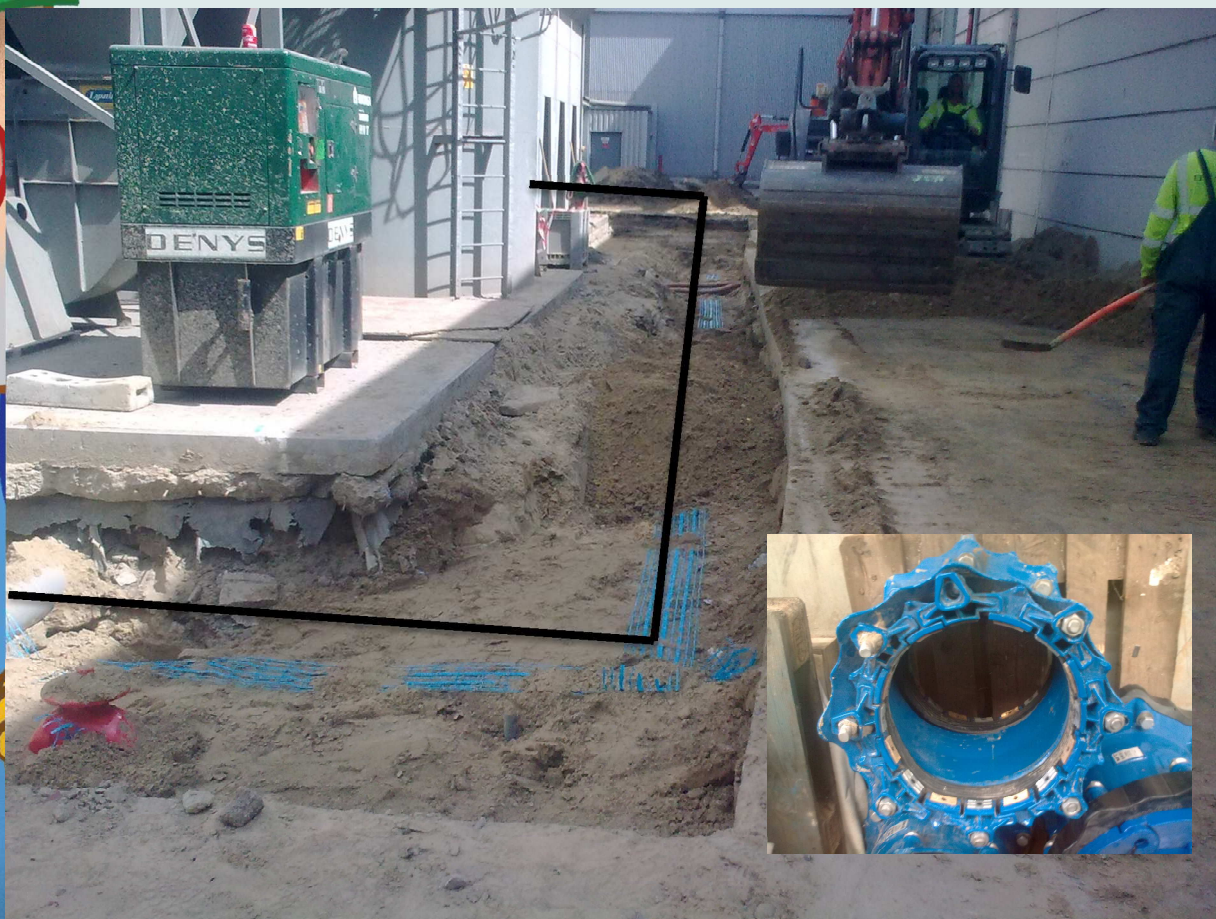
Denys had to repair a leak in a cast-iron extinguishing system in a business area. A new HDPE pipe DN300 PN16 was installed which was combined with a Supa Maxi Straight coupling to the existing cast-iron pipe DN300.
