# SAFETY ALERT

**HAND HAZARD WITH ATV WINCHES**  
**CATEGORY: OTHER (ONSHORE)**  
**CONTACT LEDCOR HSE FOR MORE DETAILS**

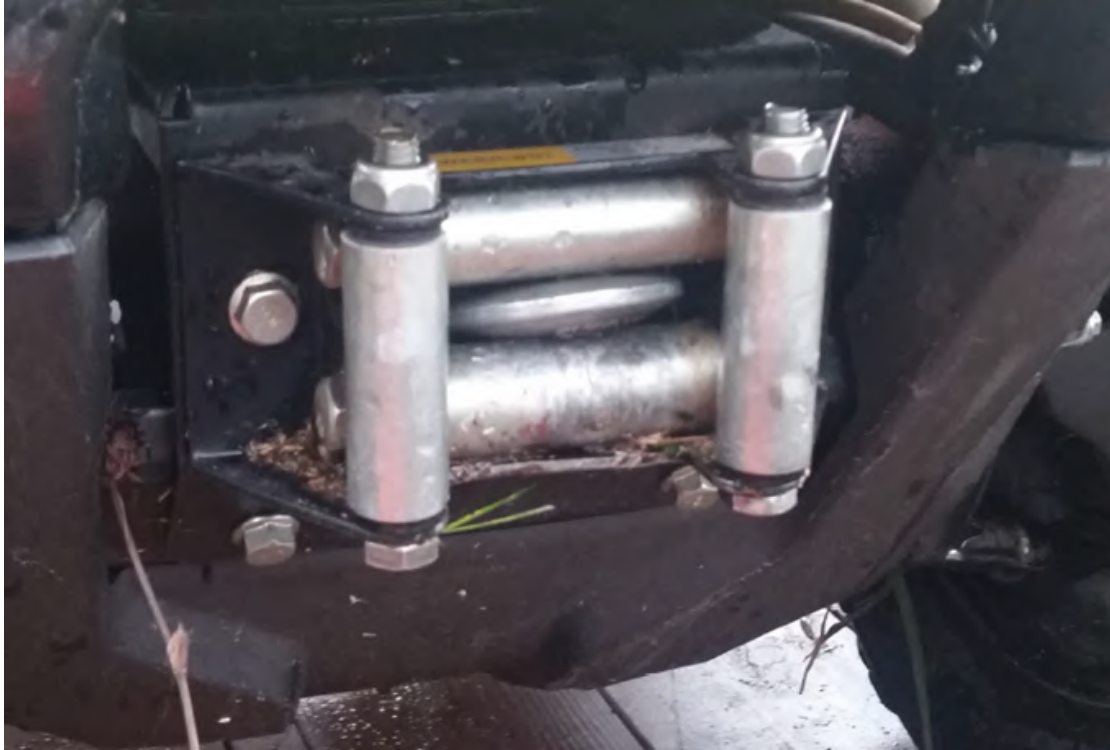
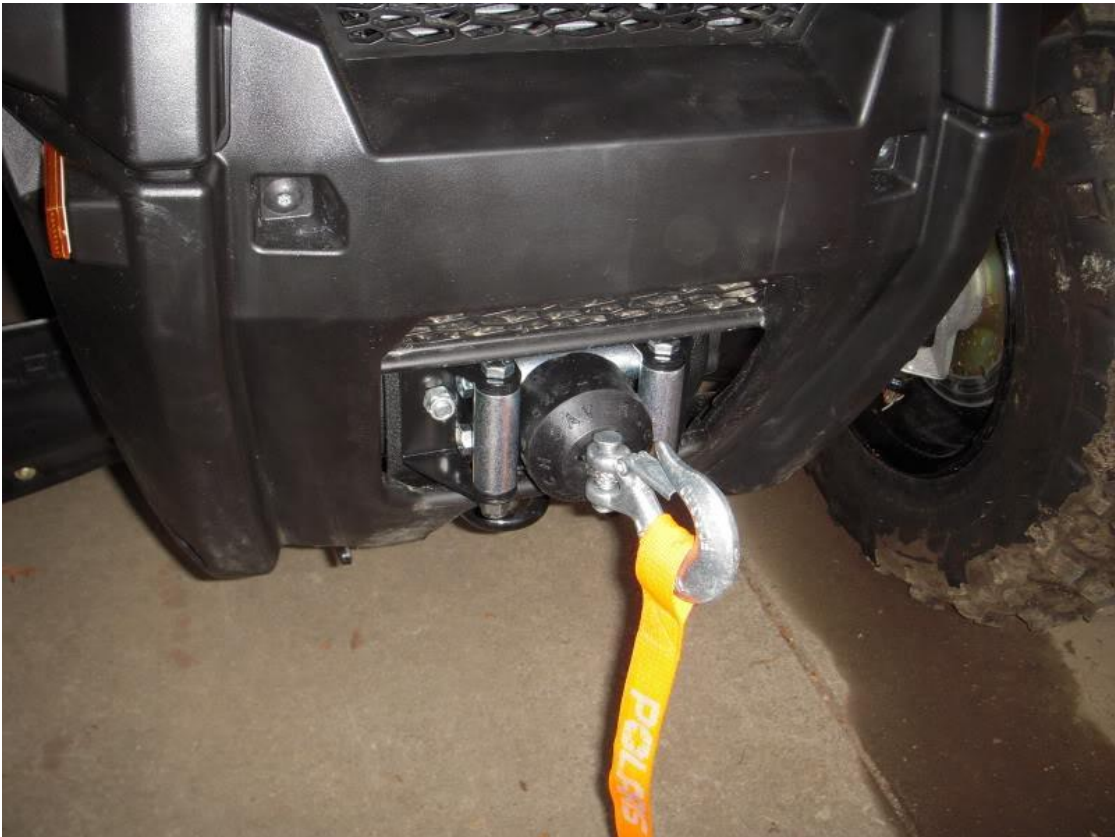
An employee was attempting to pull out an All-Terrain Vehicle (ATV) winch cable when the winch hook became stuck between the winch rollers. The employee placed their finger inside the winch hook in attempt to loosen the winch cable. During the extraction attempt, the winch retracted resulting in the employee's index finger getting caught between the hook and the two rollers.

- Safety straps attached to the winch hooks were lost and were not replaced
- Inadequate design/size of equipment –Replacement hooks were too small which allowed them to be retracted between the rollers

- All winches should have a stopper behind the hook to prevent the hook from being able to being pulled back into the winch.
- A safety strap should be attached to the hook when pulling the rope from the winch.
