LOCATION : Greece
Construction Site

INCIDENT TYPE:RECORDABLE

DATE: 05/07/2017

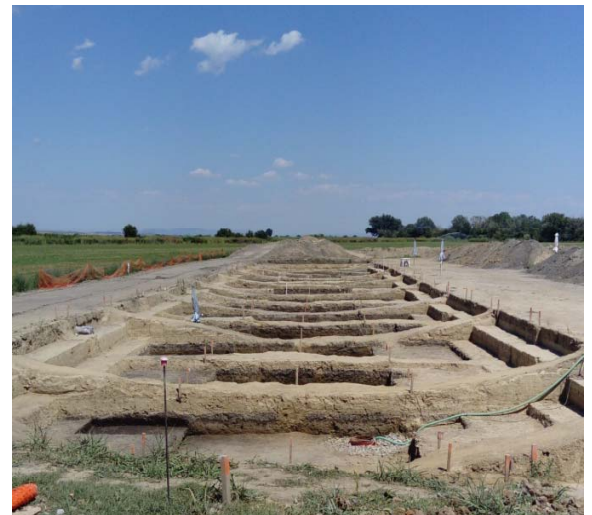
The worker was moving along a ramp of approximately 90 cm between two excavations, benched to four levels.

Series of benched excavations with ramps used for wheelbarrow access

- Implement a more thorough segregation, fencing and signalisation policy for the activities.
- Implement the use of crane and big bags to replace use of wheel barrow eliminating the risk of exposure of the worker to a fall when using the ramps.
- Issue a dedicated Method Statement describing in details the activity and inform all involved workers accordingly.

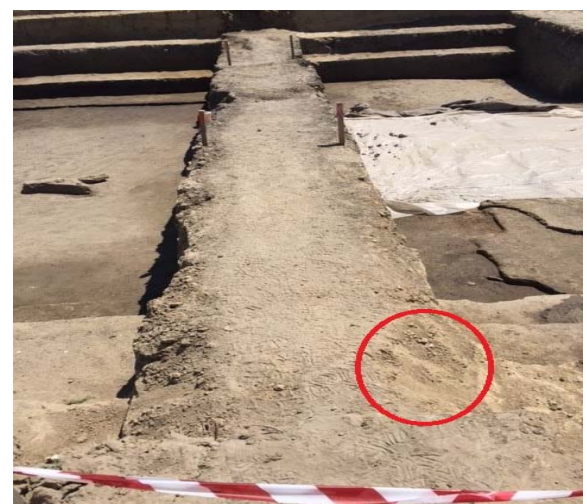
On the return trip with the empty wheel barrow he walked onto the path backwards instead of moving forward following the usual procedure. Just at the beginning of the path, the soil, frail and dry, gave way under the worker's left foot making him losing his balance and falling on the first step of the benched excavation (37 cm high). The worker fell on his left arm. The incident resulted in the fracture of the left distal radius of the worker.

Underestimation of the hazards created by the frailty of the edges of the excavation, that needed to remain open for a long time for this specific activity, exposed to meteorological events and deterioration.

Instability of the soil.

Red circle indicates where the IP lost his footing. Entry ramps were dug by a JCB and then loosely backfilled by hand
