SAFETY Alert

MAJOR ACCIDENT INFORMATION

OBJECT: FATALITY ACCIDENT INFORMATION

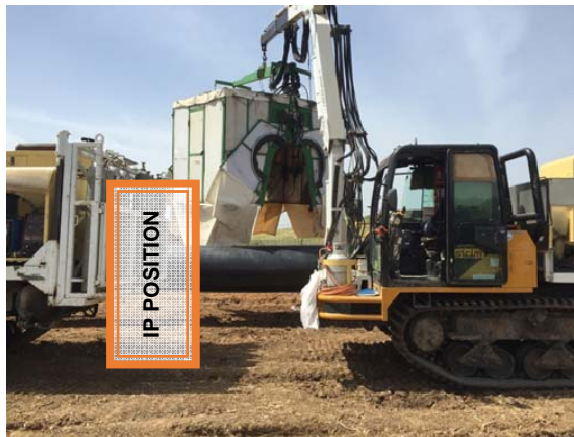
While automatic welding was ongoing, IP went on the back of the pay-welder n° 1 to check gas bottles manometers. At around 13:30, the operator moved forward the pay-welder n° 2 and hit against the first one crashing IP between the front of the pay-welder n° 2 and the bottles cage of pay-welder n° 1 (See Picture below). The operator of PW n°1 realised the impact, went down from the pay-welder, REALIZED what happened, ordered PW n° 2 to go backward and started emergency procedures.

- Major accident: Fatality;
- Stopped the activities;
- Investigation ongoing by authority and SICIM Corporate Management.

- Mishandling of the Paywelder;
- Underestimated Risk of operating so-considered "light construction equipment";
- Failure to Operate equipment without authority (no operator competence assessment performed);
- Using equipment or materials improperly (Operator has or could have used improperly the PW n° 2);
- Failure to follow procedure (PW n° 2 should not have been moved after last weld grinding);
- Failure to comply with road laws and regulations/Driving policy;
- Lack of competence;
- Lack of / inadequate training and / or information;
- Wrong or inadequate change management (the day of the incident the operator used a PW with a different operating system than the one previously used).

Several measures implemented to avoid the repetition of other similar episodes:

- ✓ Review the heavy equipment operators competence assessment process;
- ✓ Review Corporate Operator Assessment procedure for all equipment and establish an internal Operator Assessment process for all equipment;

- ✓ Ensure Operators only operate Equipment they have been assessed for;
- ✓ Develop proper user's manual for all operative equipment, starting from Paywelders, reflecting actual configuration and operating system of different assembled piece of the equipment;
- ✓ Ensure above actions is cascaded to Sicim Corporate and Projects by the issuance of Safety Alert.

- ✓ Develop training material for all Equipment – such as Paywelder to ensure operating system differences are properly highlighted to operators;
- ✓ Develop a Corporate Supervisor training standard and implement in all site.
